NOTICE OF PUBLIC MEETING

Monday, May 9, 2022
City Council Chambers
680 Park Avenue
Idaho Falls, ID 83402
3:00 p.m.

- Presentation: Holmes Avenue Road Safety Audit (30)
Action Desired: Council Direction to Staff
- Presentation/Discussion: Water Meter and Advanced Metering Infrastructure (AMI) Vendor Selection (30)
Action Desired: Council Direction to Staff

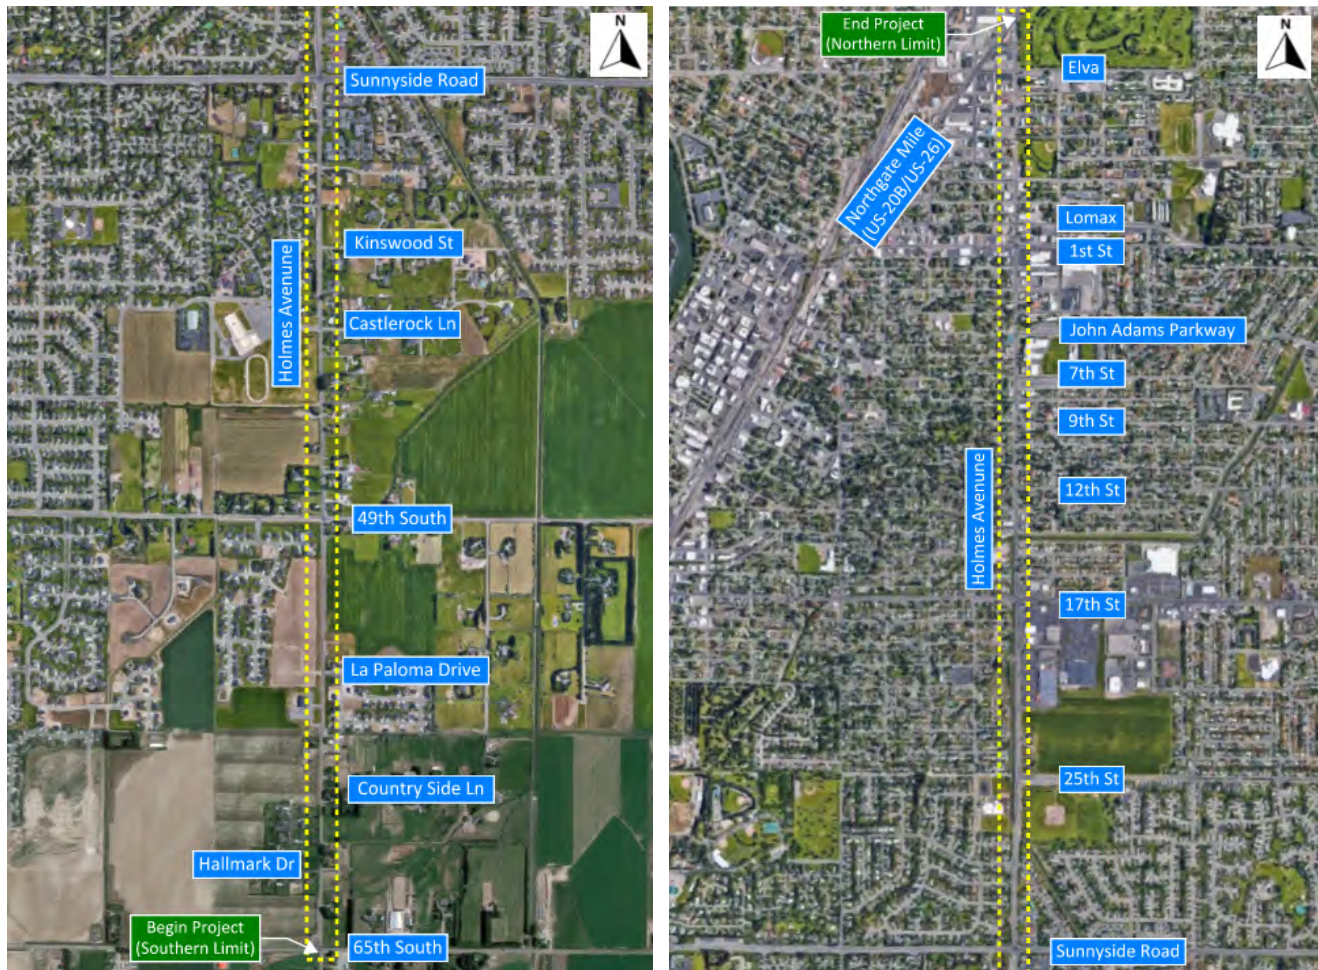
Figure 1 - Holmes Ave., 65th South to Northgate Mile.

Figure 1 shows the limits of the project and the major cross streets.

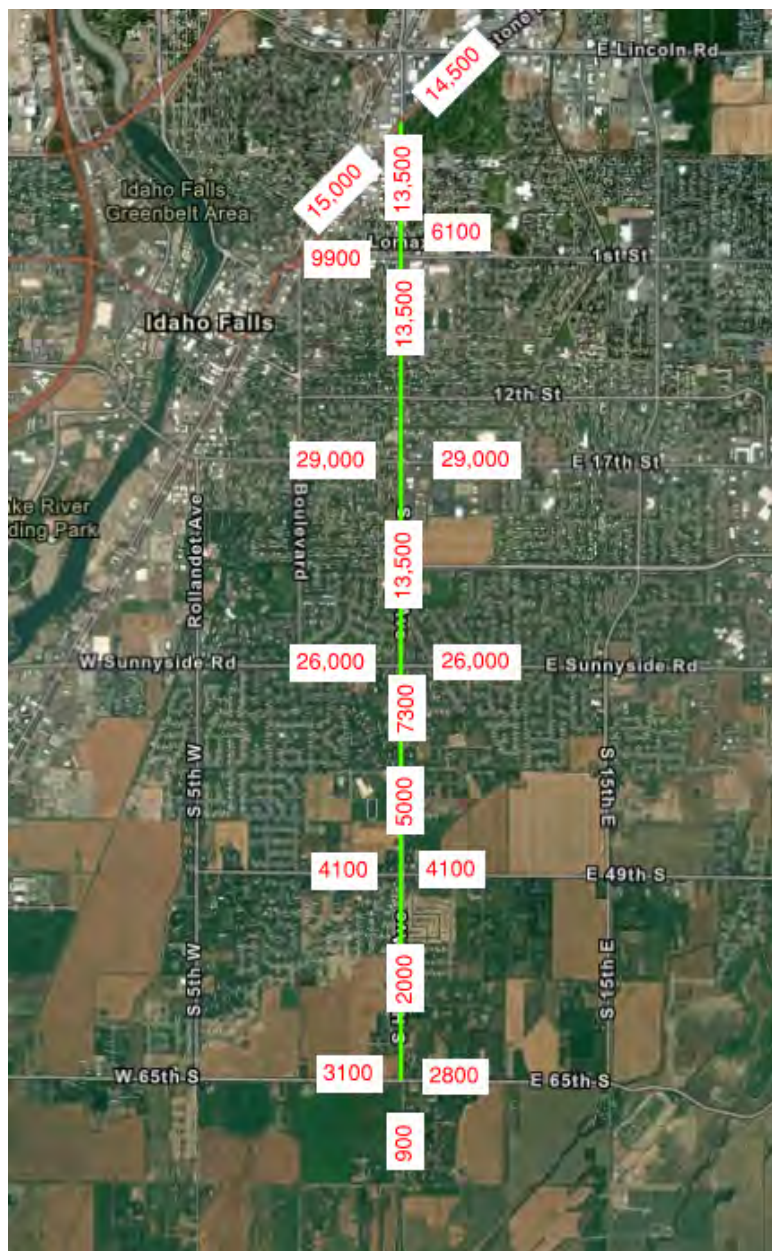
Figure 2 - Annual Average Daily Traffic for Holmes Avenue and Major Cross Streets

An in-depth study of the traffic volumes, specifically looking at hourly counts, weekday/weekend traffic, and seasonal change, may reveal the varying use of each section.

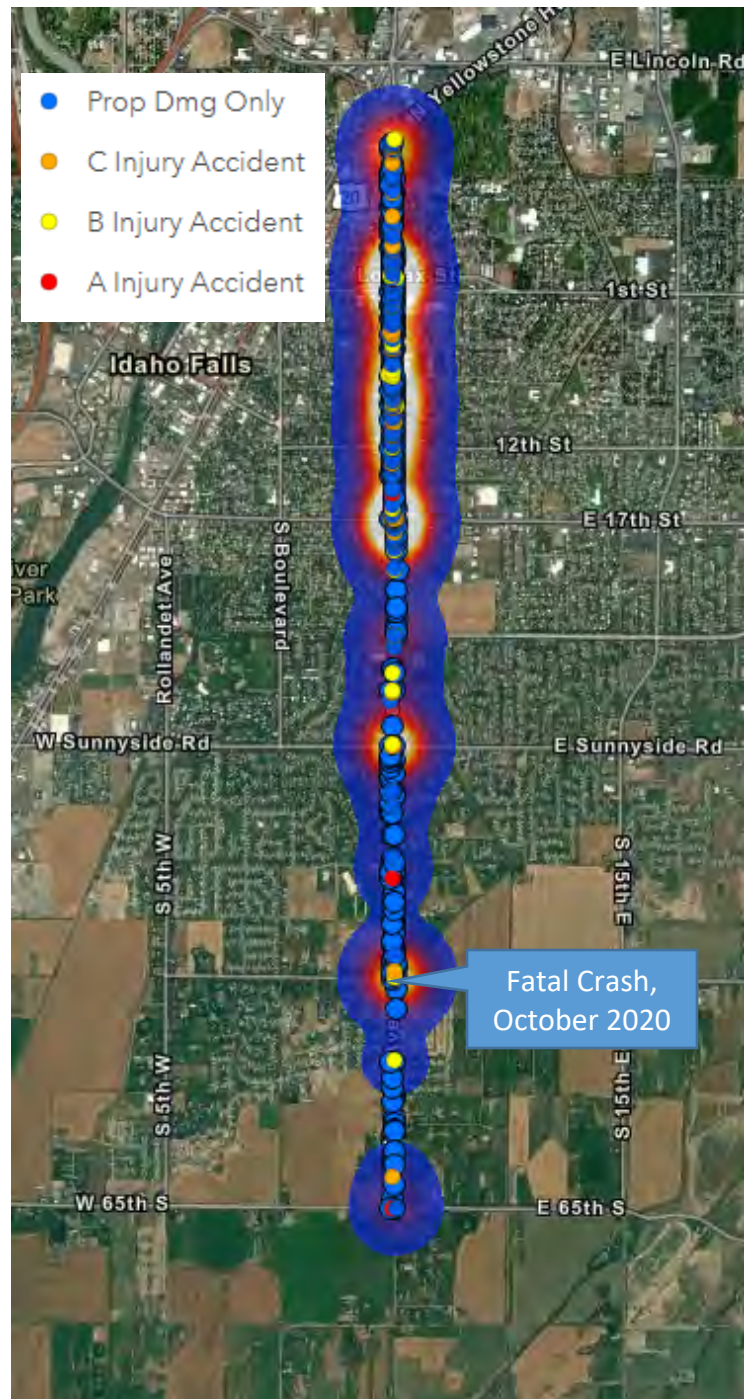
Figure 3 - Crash Data from 2015-2019

The intersection crash rates range from 0.27 crashes per million vehicles entering (MVE) at 1st Street, to 1.66 crashes per million vehicles entering at 49th. Except for 49th, all the crash rates were below 1.00 MVE.

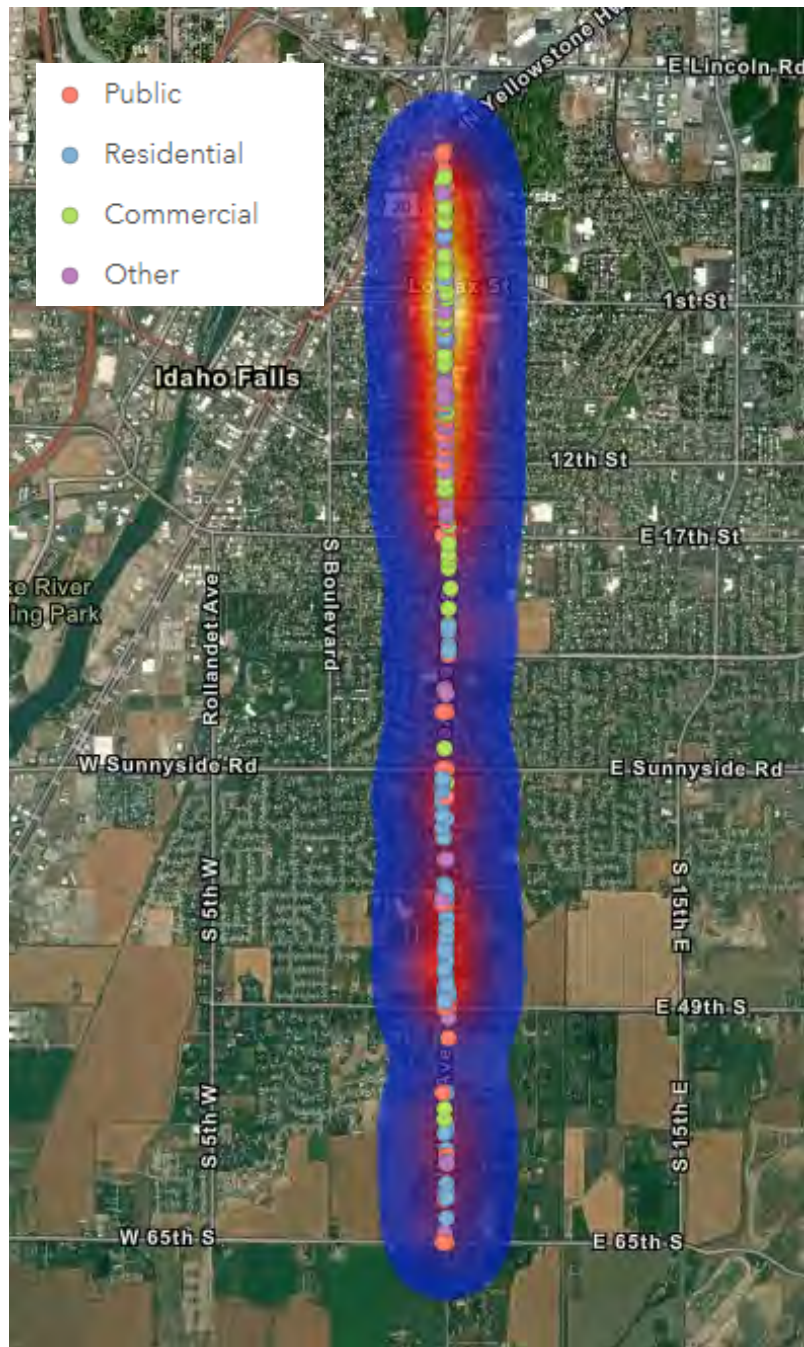
Figure 4 - Access points

On Holmes Avenue, there are a total of 220 access points, however, 129 of those access points are from 17th Street to Northgate Mile. Thus, from 65th South to 17th Street, the access density is about 15 access points per mile per side, and the average spacing is approximately 355'. The access density from 17th Street to Northgate Mile is about 40 access per mile per side, and an average spacing of 130'.

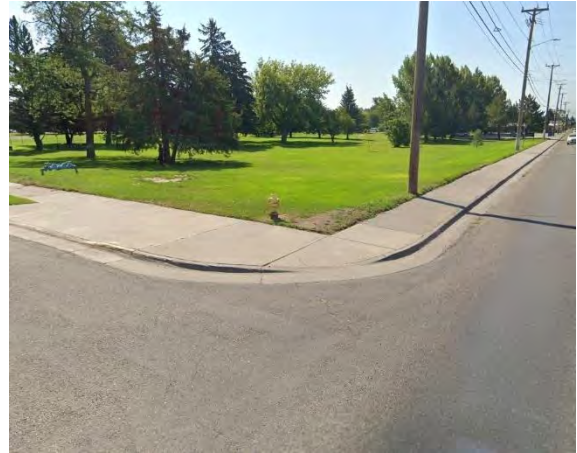
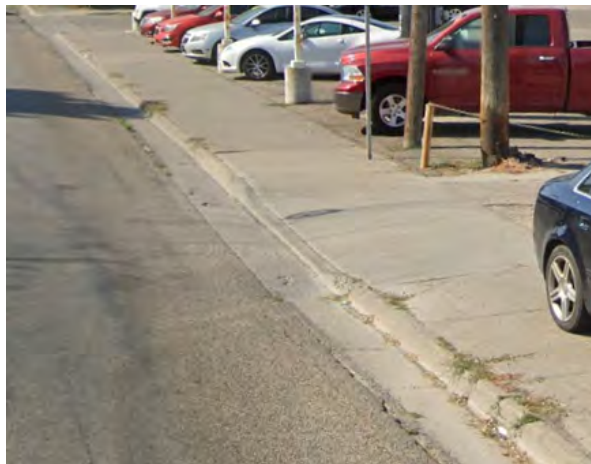
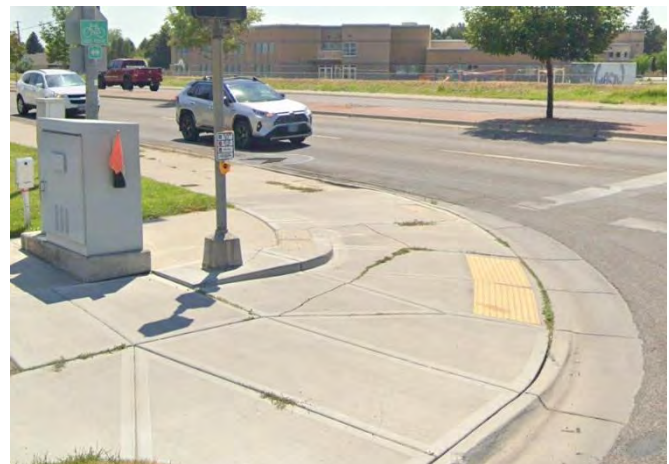
The newest sidewalks and pathways were for the most part ADA compliant; however, the older or dated sidewalks were narrow, and were lacking some of the basic ADA features such as Landings, Detectable Domes, and Ramp Slopes. Also, some of the existing sidewalks have shifted, causing tripping hazards. The older sidewalks were also not adjusted for the driveway curb cuts, and only tipped towards the road to allow vehicle access. Figures 6-8 show a few of the non-compliant pedestrian facilities.

Figure 6 - Pedestrian Ramp at May St

Figure 7 - Driveway Curb Cut near Elva St.

Figure 8 - Pedestrian Ramp at 25th St.

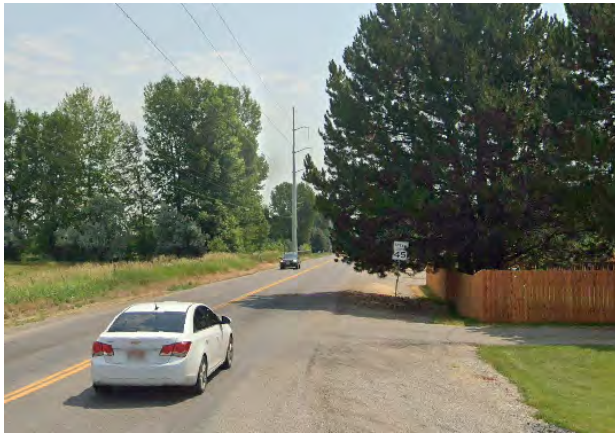
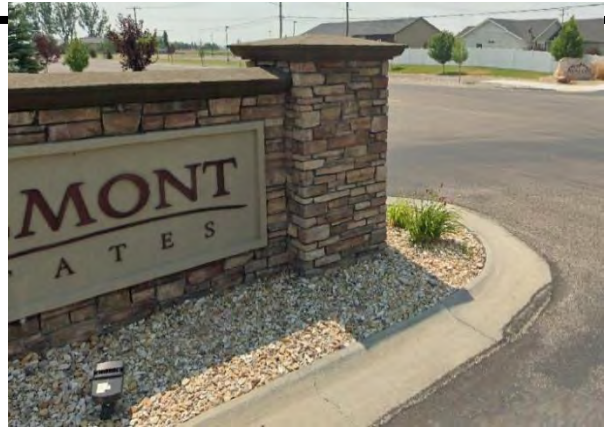
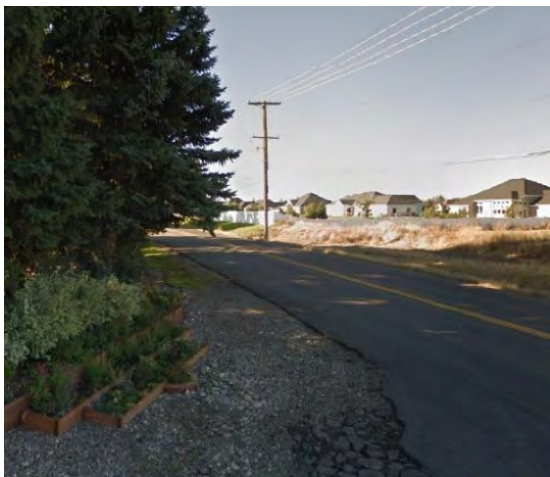
Sight Distance for the public road intersections and some of the subdivision entrances were limited by objects or vegetation. Although the existing sight distances may exceed the minimum standard for a stop or yield controlled intersections, additional vegetation clearing, or object removal/relocation would increase the ability to see approaching vehicles, pedestrians, and bicycles. Figures 9 – 11 show examples of limited sight distance.

Figure 9 - 65th South looking East

Figure 10 - La Paloma Dr. looking South

Figure 11 - Countryside Lane looking South

Countryside Lane on the east side has older homes and more established vegetation that encroaches into the roadway Right-of-Way, and at times hangs over the northbound lanes. See Figure 11.

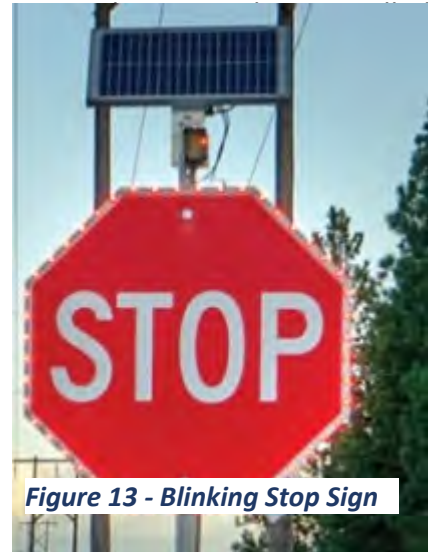
Figure 13 - Blinking Stop Sign

- (I1-3) Add Flashing Stop Blinking stop signs that are activated by the speed of approaching vehicles tend to be more effective than those that blink 24/7. See Figure 13.

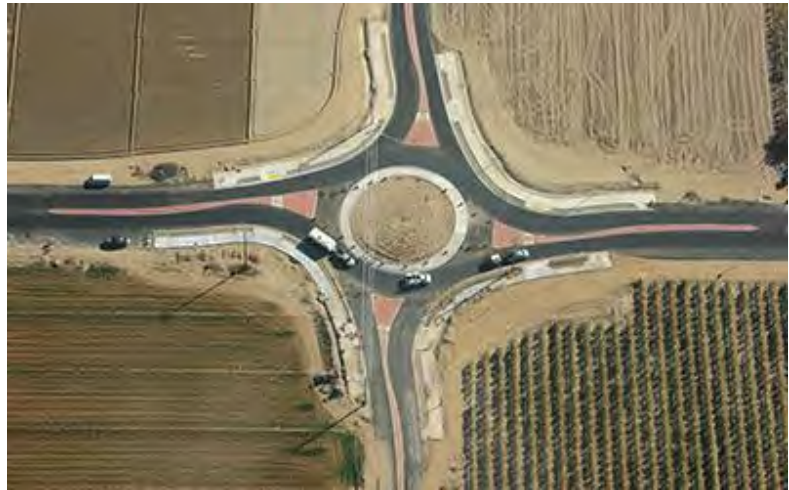
Figure 16 - Typical Rural Roundabout

Per the Crash Modification Clearinghouse, the crash reduction factor for installing a roundabout in a rural area suggests a 60% reduction in crashes.

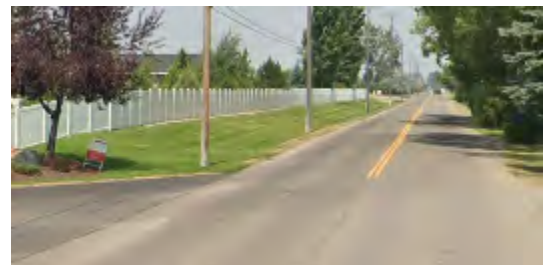
Figure 17 - Hallmark Estates looking North

This section of Holmes Avenue is very much a transitional type of roadway, containing variable cross sections between rural and urban areas. Near the southern end, there are two isolated subdivisions with a single access onto Holmes Avenue. Hallmark Estates on the west is relatively new and the development planted grass between the edge of the roadway and the vinyl fence as shown in Figure 17.

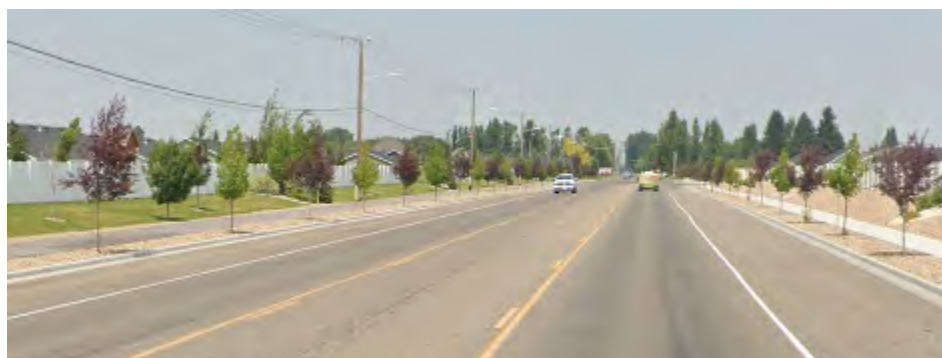
Figure 18 - Belmont Estates (right) and Avalon (left)

Near the north end of this section, two new subdivisions have been developed and provide a wide roadway, with curb, gutter, sidewalks, pathways, planter strips and vegetation. These subdivisions are

located inside the City of Idaho Falls and the power poles on the west side have been set back behind the pathway. See Figure 18.

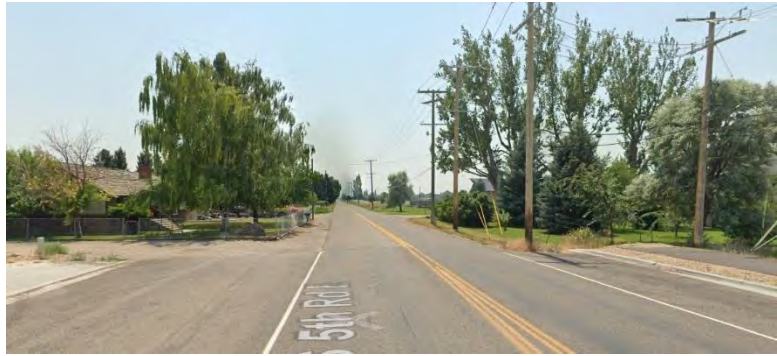
Figure 23 - South End of Belmont Estates, looking South

The team really liked the sidewalks and pathway near the Belmont Estates and the Avalon Subdivision; however, they end abruptly. See Figure 23 and 24. The team suggested that the pathway on the west side could be extended south of the Cornerstone Church in front of the farms, homes, and in the vegetated frontage to Hallmark Estates. This would greatly improve the pedestrian access to both subdivisions, the church, and any other subdivision planned along that stretch.

(S1-6) The team determined that a long-range project could be implemented to extended curb, gutter, and sidewalk south from Belmont Estates and the Avalon Subdivision to Hallmark Estates and Countryside Lane.

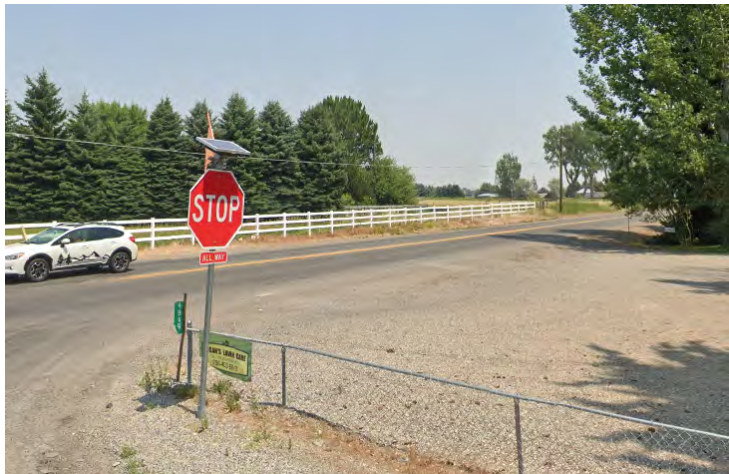
Figure 25 - Blinking Stop Sign at 49th South

Although the county has made some minor improvements to increase the safety of the intersection, the team has identified a few other counter measures that could help both the safety of vehicles and pedestrians.

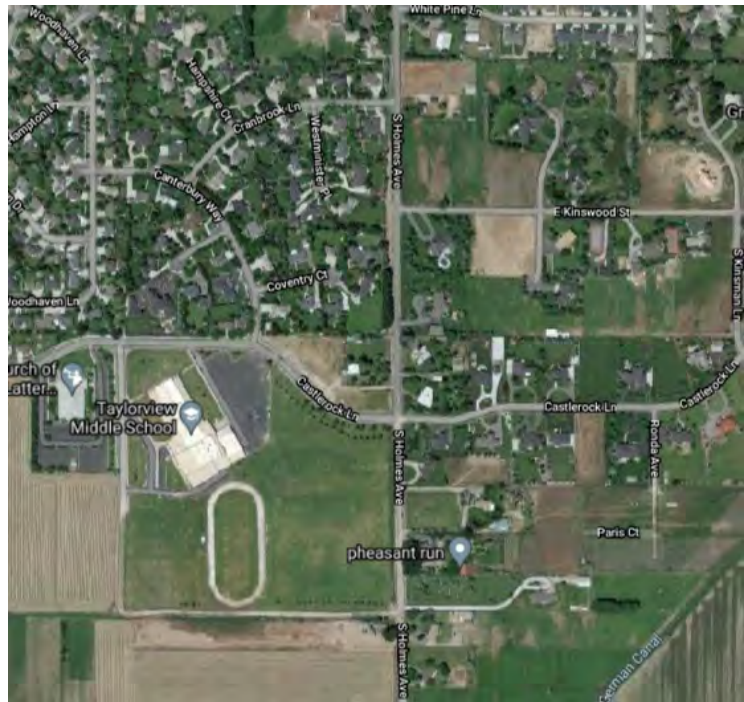
Figure 28 - Taylorview Middle School

This segment of Holmes Avenue traverses through mostly developed residential areas with only a few open farms or pastures. However, the roadway cross-section is a rural two-lane roadway with no pedestrian facilities. Centered in the middle of this segment is Taylorview Middle School, which does have an active RRFB and crosswalk markings to cross Holmes Avenue to Castlerock Lane. See Figure 28.

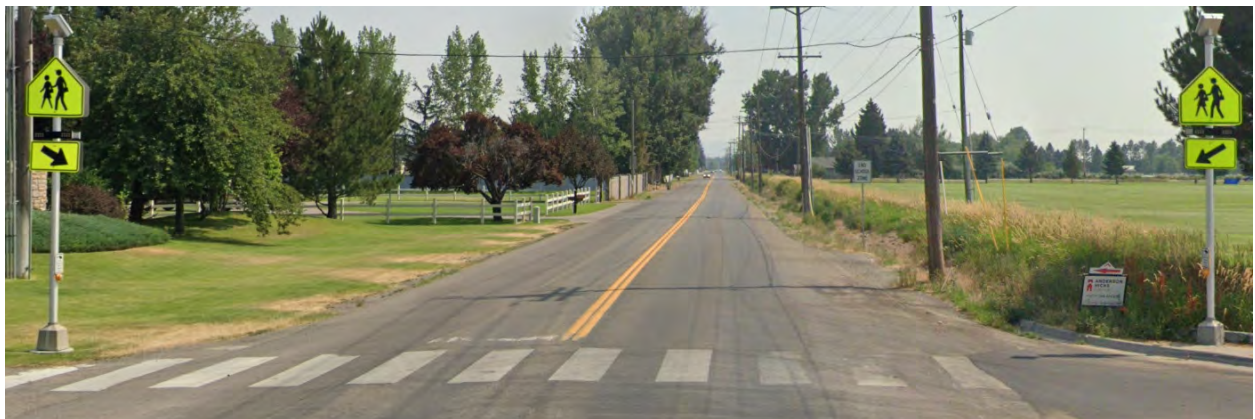
Figure 29 - School Crosswalk with RRFB at Taylorview Middle School

The team did observe several vehicles queued up on Castlerock Lane after the schools released in the afternoon; however, it was cleared within 15 minutes. Only 10-15 students used the crosswalk and RRFB to access the east side of the roadway. See Figure 29.

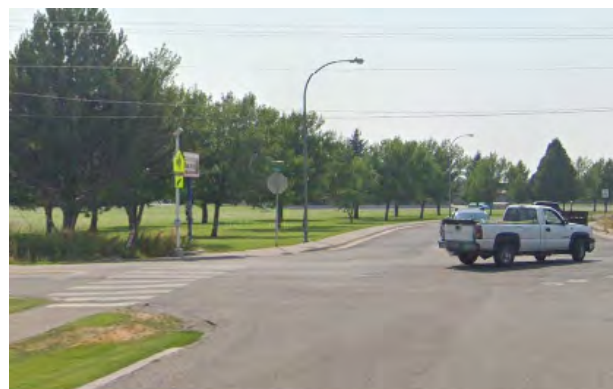
Figure 33 - Castlerock Lane looking West

During the nighttime field review, the team identified that the intersection near Castlerock Lane was not very visible. Depending on the time of the year or the activities at the school, there is a potential that pedestrians would be using the marked crosswalk at night. The team suggest that adding intersection lighting would, not only increase safety for pedestrians and motorist at night but increase driver and pedestrian comfort when traversing through the intersection. (S2-5) See Figure 33

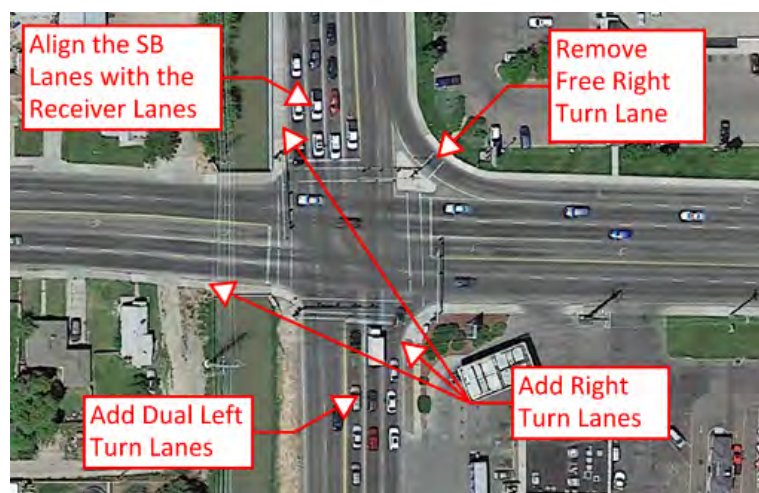
Figure 41 - 17th and Holmes

One final item that the team noticed was that the southbound traffic entering the intersection is required to make a 5-7' shift in the intersection to match into the proper receiving lane. Shifting the lanes over would be difficult with the right-of-way constraints; however, a properly aligned intersection would reduce the occurrences of side-swipe type crashes.

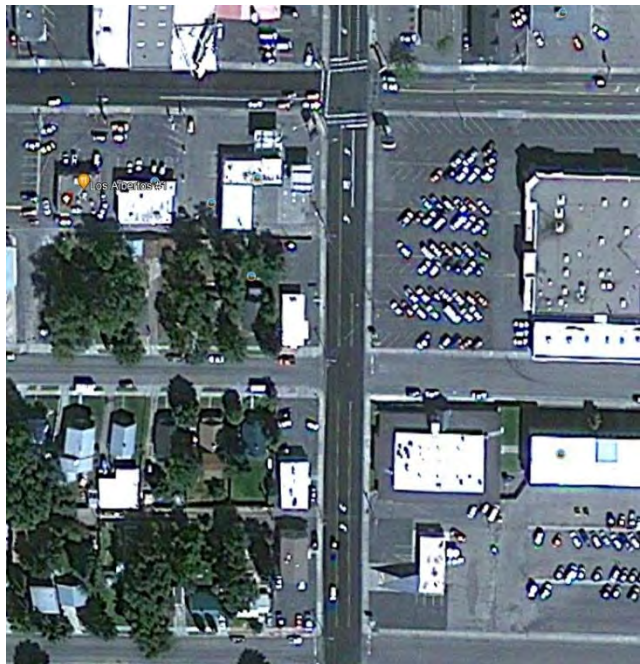
Figure 42 - Holmes Avenue in 2010

In 2010, the city determined that there would be a safety and operational benefit to perform a road diet on this route, reducing the lanes from four to three. At the time, the demand for thru traffic was not as high, and thru motorists benefited by having wider lanes, and a center left turn lane. Pedestrians also benefited by only having to cross three lanes of traffic instead of four. See figure 42.

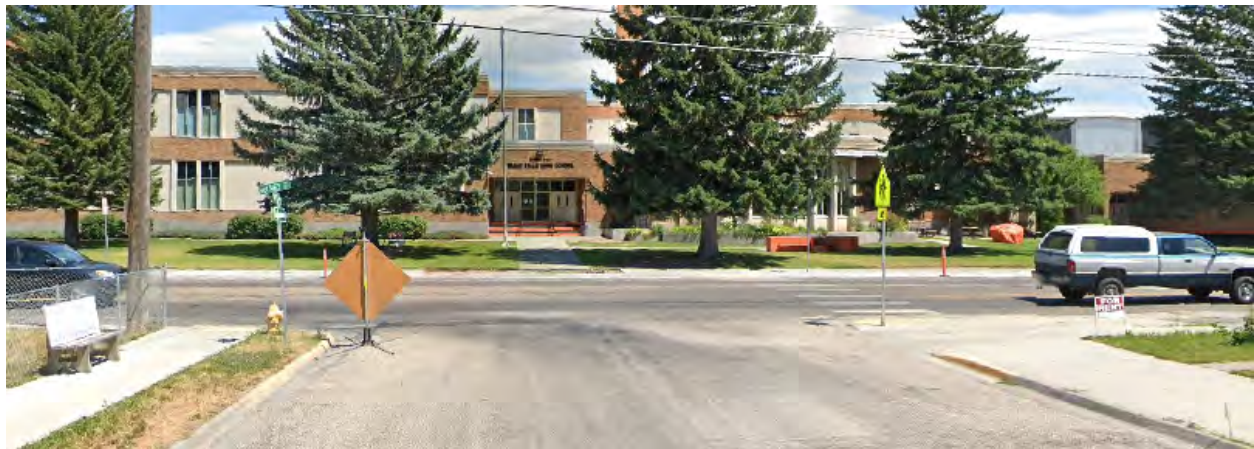
Figure 48 - 6th Street Intersection

The team also noticed during the afternoon school release that there were several students that crossed at the unsignalized intersection at 6th Street. 6th Street is a T intersection with Holmes Avenue; however, 6th Street lines up directly across from the main entrance into the High School. Although the intersection has painted crosswalks and school crossing signs, the team determined that a HAWK signal or RRFB could be installed at this location. (S4-11) Also, the distance to cross the roadway could be shortened by install sidewalk bulbouts. (S4-12) See Figure 48.

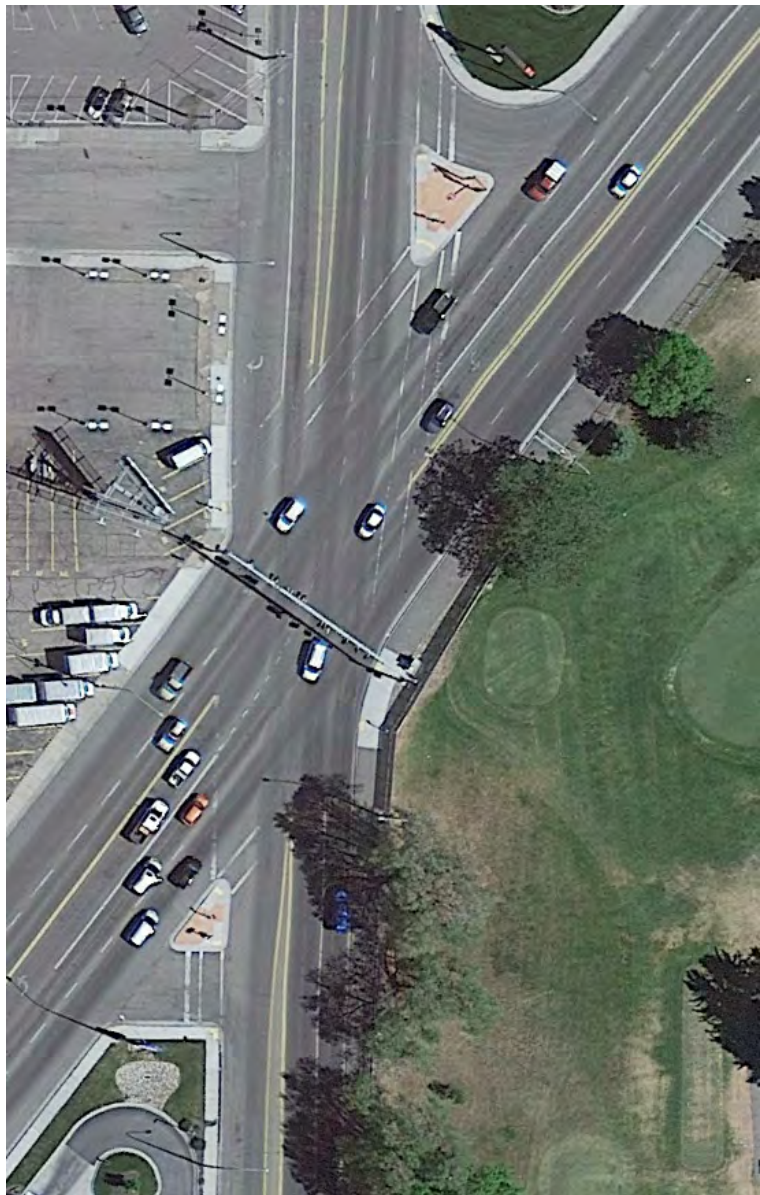
Figure 51 - Yellowstone Highway and Holmes Avenue

Since three of the four legs of this intersection are on the State Highway System, coordination with ITD would be required for any safety improvements or changes to its operations. Thus, the suggestions provided by the RSA Team are to be further evaluated and analyzed to ensure they provide the desired benefits.
